# **AsiaTeak Tropical plantations**

**Vision Forestry Company (PVT) LTD.**

**Dates of the visit: - 19th February to 23rd February 2018**

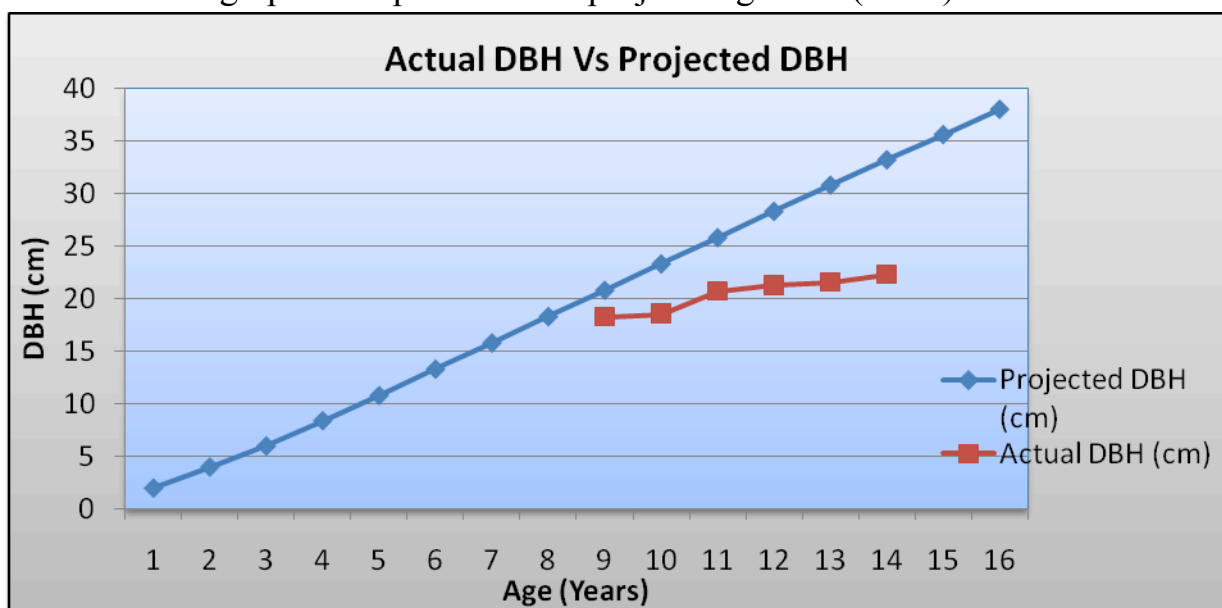
Growth graphs comparison with projected growth (DBH)

According to the analyzed data in U-Thong estates, It is already achieved the more than 50% from the target within this short period of plantation under the management of Thai orchid lab company in Thailand and supervision of AsiaTeak plantations company. But it will has to be manage more additional years to harvest good quality timber with high value.

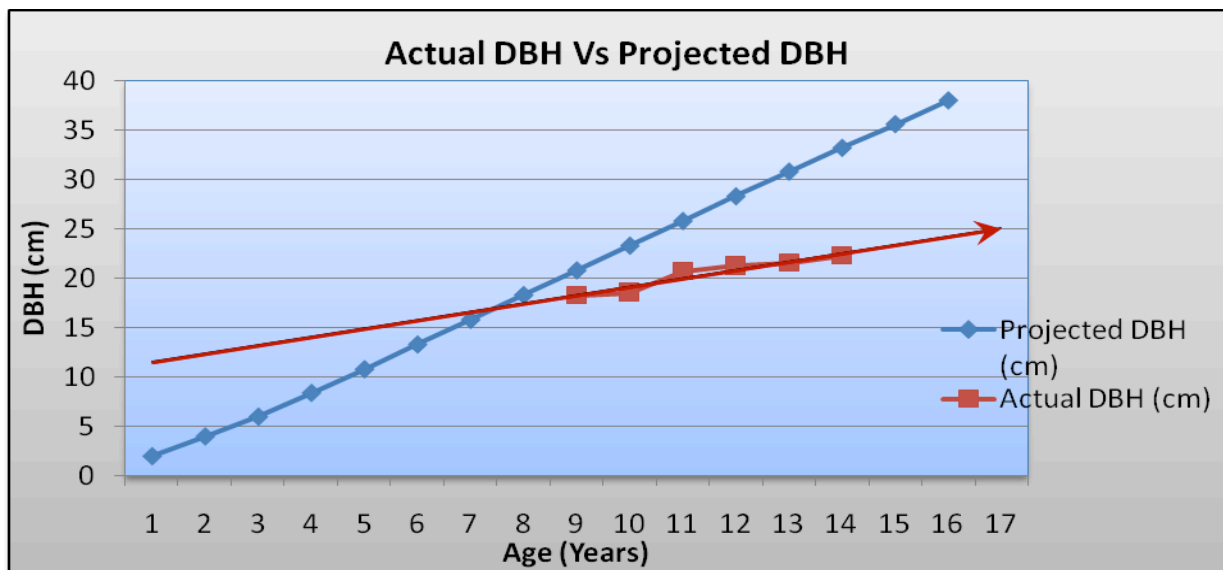
## Growth graph with projected trend line of future growth

Projected timber volume can be obtained from the additional teak stock in buffer stock plantations within projected period without any hesitations. Timber value can be increased by comprehensive timber quality improvement programme within this period.

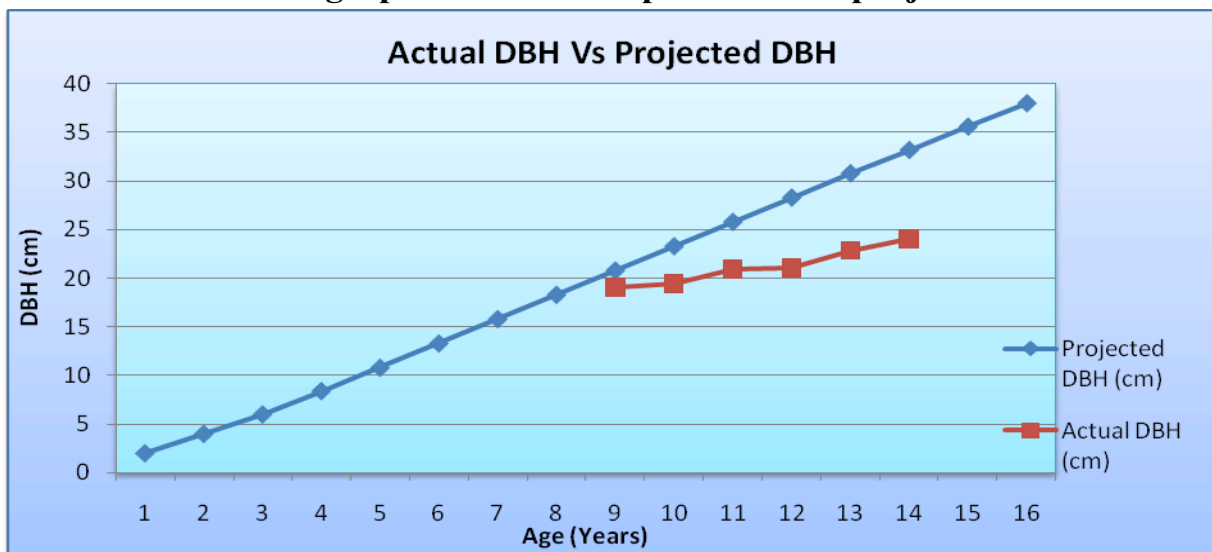
### Growth graphs of DBH comparison with projected

When consider the analyzed data in Chon Daen estates, it is very important to implement some timber quality improvement programme to add value for standing Teak trees in the plantation.

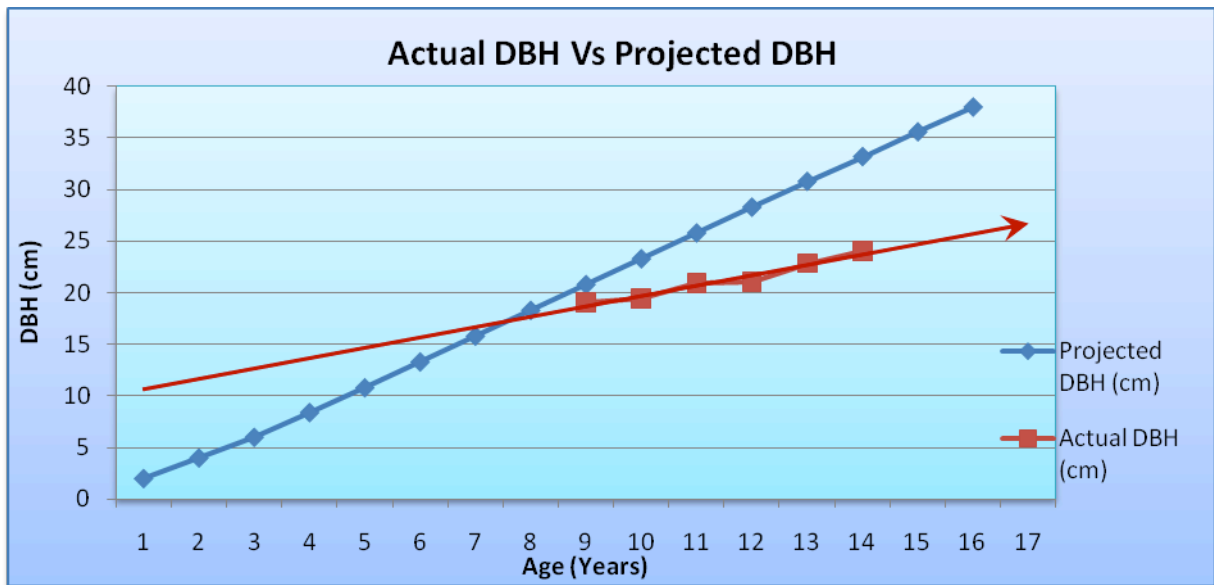
## Growth graph with projected trend line of future growth

Most of trees in Chon Daen estate will be achieved the 70 % of growth target within the projected period and among these trees, considerable

amount of trees will achieve the 100 % of growth target within the projected time line.

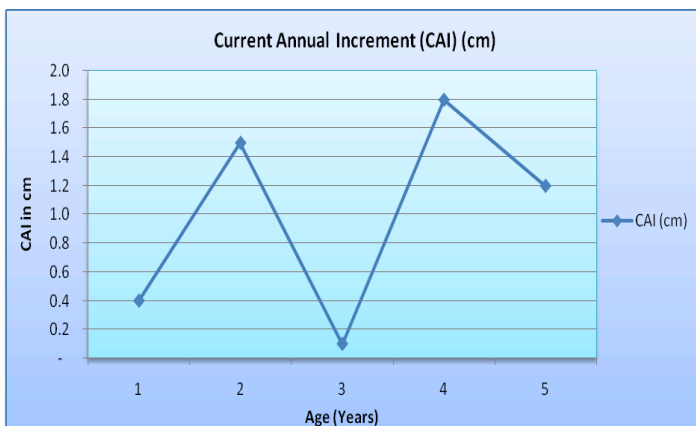
## Current Annual Increment and Mean Annual Increment

Bad climatic and weather conditions have been negatively effected to the slow growth of DBH of Teak trees in this area. It can understand by Current annual increment in before last year. But this condition could be positively affected to the quality of timber. It is tended to increase the hart wood percentage of timber.
